5105-28, Rev. A Solar Thermal Power Systems Parabolic Dish Project Research and Advanced Development DOE/JPL-1060-37 Distribution Category UC-62b

Status of JPL's Experience with Thin 7809 Glass for Solar Energy Applications

REPORT No. 1

October 1, 1980

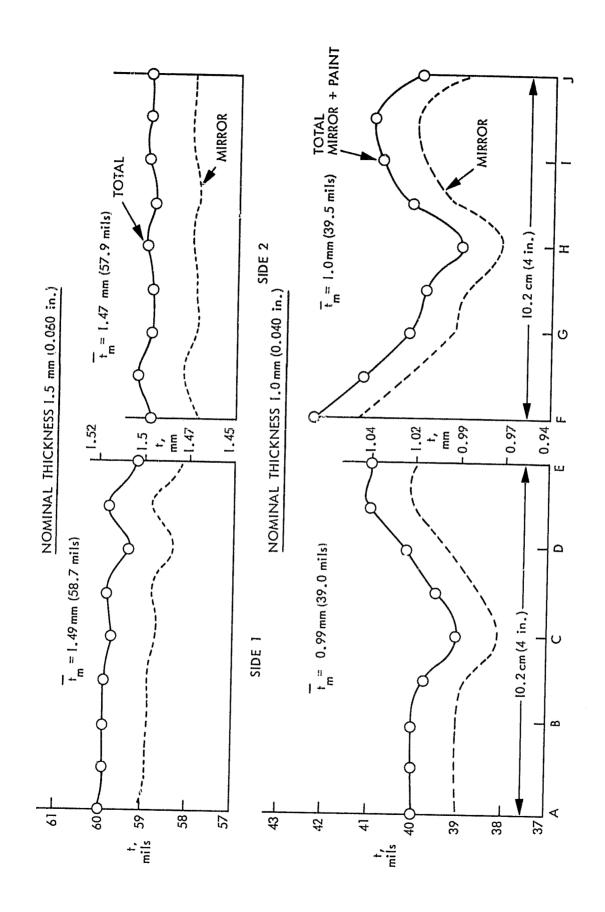
Results of Thickness Measurements (Across Draw Direction) Figure 2.

Upon receipt, the length, width, and thickness of each lite was measured and tabulated. Considerable variations were observed in most dimensions (Table 4). A 10.16-cm x 10.16-cm (4-in. x 4-in.) sample of each of the two types of mirrors was measured. These preliminary results, shown in Figures 1 and 2, assume a one mil thick paint coating. These samples were arbitrarily selected and should not be interpreted as characteristic of the entire shipment. The measurements shown are for two opposite sides of each sample measured across the draw. The variation with the draw was not as noticeable when judged by eye.

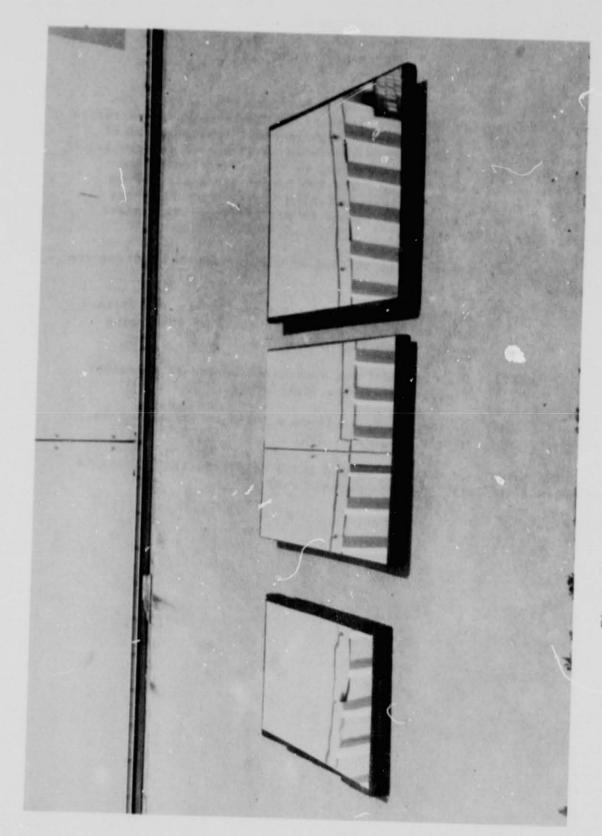
Figure 3. Mirrors Bonded to Cellular Glass

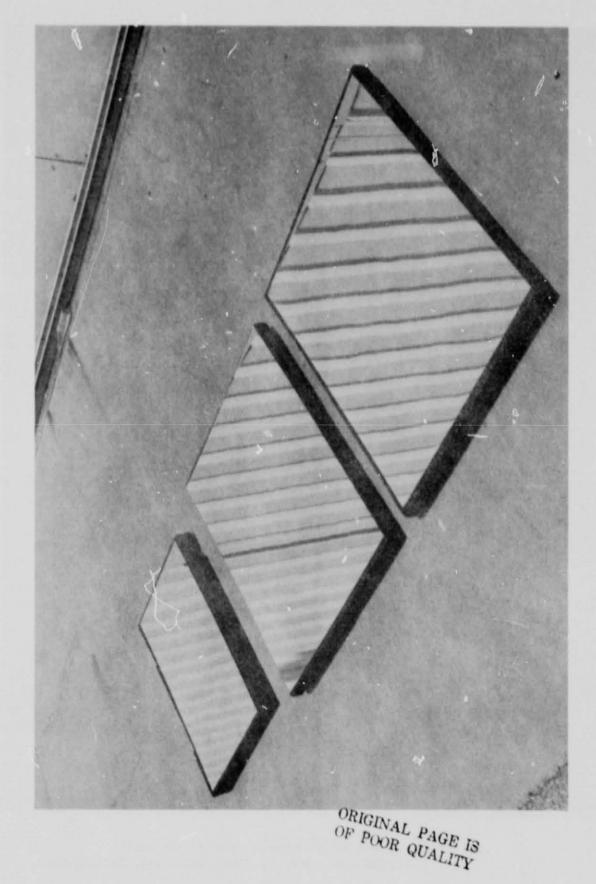
Outdoor deployment efforts using the Code 7009 mirrors are currently underway at JPL. Mirror gores for technology demonstration and environmental testing are being fabricated. Typical gores of mirrors bended to cellular glass are shown in Figures 3 through 5. The waviness of the mirrors is evident by the reflection of the parallel lines of the building. The two larger gores are 1.5-mm (0.060-in.) thick and approximately 0.61-m (2-ft) square. These particular mirrors have been fastened to blocks of cellular glass substrate for adhesive tests.

figure 4. Reflection of Vertical Door Lines on Curved Mirrors

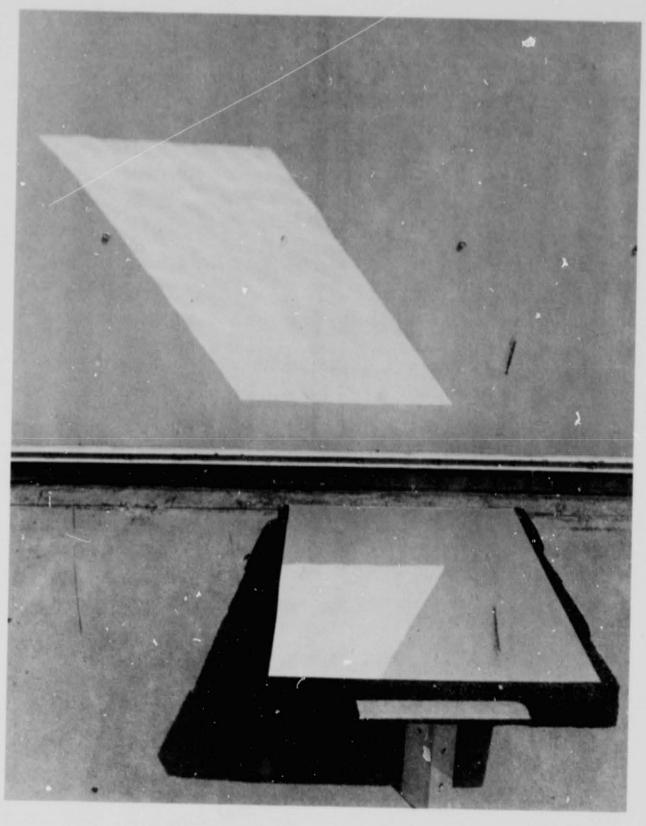
Figure 5. Reflection of Mirror Pattern on Wall (10:00 a.m., May 5, 1980, Pasadena, California)

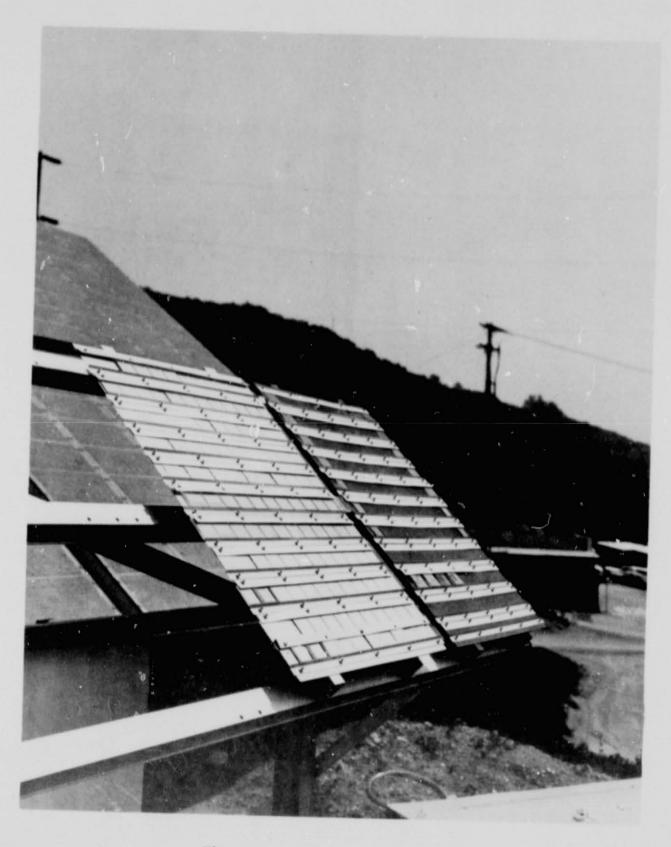
Figure 6. Outdoor Exposure Rack

- (1) Deployment of 4.8-cm x 4.8-cm (1.9-in. x 1.9-in.) samples at JPL on exposure racks at 45° facing south. (See Figure 6.)
- (2) Deployment of the same size samples at Goldstone Test Site, Barstow, California.
- (3) Deployment of 10.16-cm x 10.16-cm (4-in. x 4-in.) mirror samples at JPL.
